**Tier 1 Report of  
Facility Condition Assessment**

**For  
City of Los Altos  
Restroom Building  
97 Hillview Avenue  
Los Altos,  
California 94022-3740**

**Date of Report: June 10, 2016**

**Faithful+Gould, Inc.**

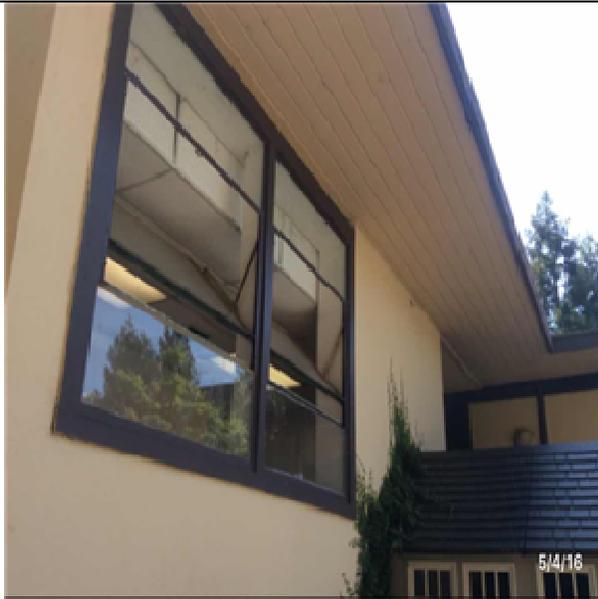
The exterior soffits appeared to be in fair condition; therefore we do not anticipate any actions during the study period. We do however recommend repainting of these surfaces later in the study period to maintain the appearance of the building and also protect the asset.

B2016 Exterior Soffits:- View of Exterior Soffits

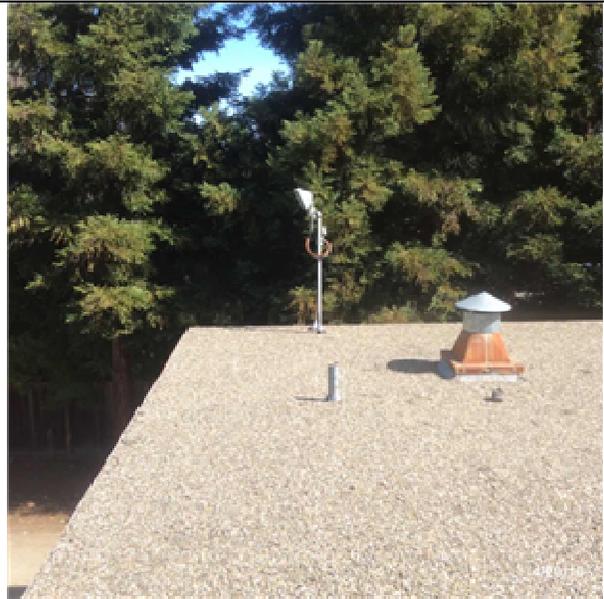
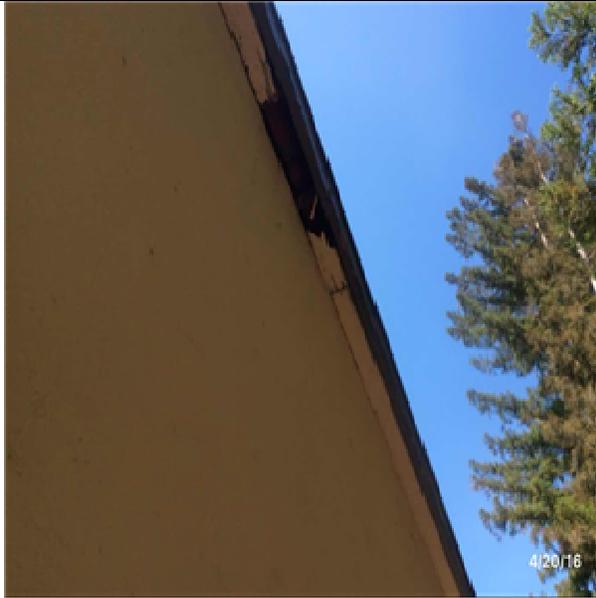
The BUR covering appeared to be in poor condition with evidence of leaks observed. The maintenance personnel also verified reported roof leaks. There is deterioration due to age and other similarly aged roofs to the Community Center have already been repaired. We are unaware of the age of the roof covering, however we assume it to be more than fifteen years of age, therefore based on the typical EUL of twenty years for this type of covering and current observed condition, we anticipate replacement early in the study period.

B3011 Roof Finishes:- View of BUR (Built-up Roofing) System

ID	Type	Recommendation	Priority	Year	Expenditures
135357	B3010	Replace roof deck and covering	Priority 2	2016	\$15,575
135358	B3010	Replace Galvanized Steel Perimeter Gutters & Downspout	Priority 2	2016	\$635

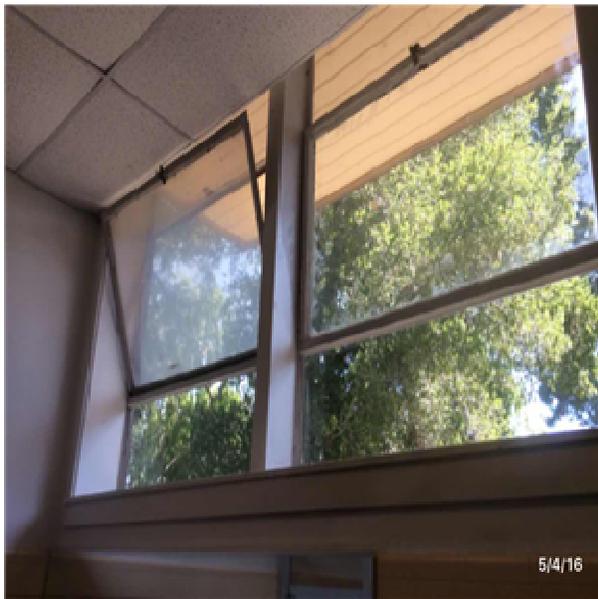
The windows at the building were observed to be in poor condition. We have assumed the windows to be original based on the current condition, which would put the windows well past their useful life. Glass has been replaced recently due to difficulty of operation, and the frames showed signs of rust and corrosion. We recommend replacing the window immediately in order to maintain the appearance and security of the building as well as prevent water penetration.

B2021 Windows:- View of Steel Window Units - Casement, Double Hung, Vent or Sliding

ID	Type	Recommendation	Priority	Year	Expenditures
135355	B2010	Repaint Exterior Wall Surfaces	Priority 3	2018	\$1,676
135356	B2020	Replace Steel Window Units - Casement, Double Hung, Vent or Sliding	Priority 1	2016	\$6,819

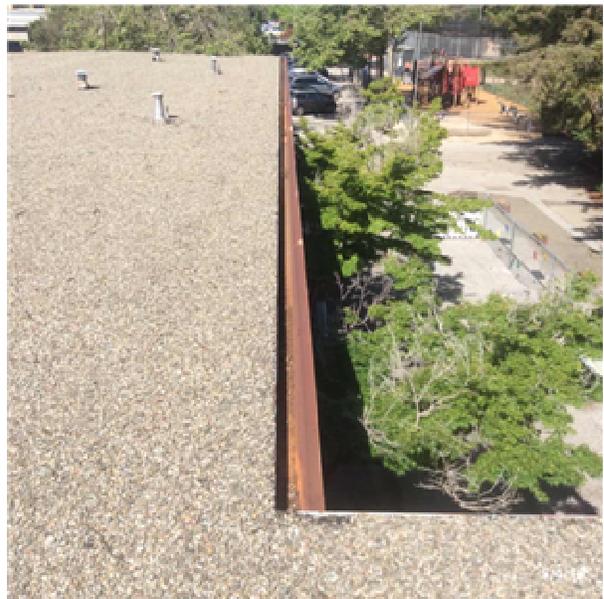
The gutters appear in poor condition. Maintenance personnel reported that the gutters and down spouts are difficult to maintain due to the fact that they are connected directly to the below ground drainage. The typical EUL for this type of gutter system is twenty years; therefore, we recommend replacing the gutters and downspouts at the beginning of the study period.

B3016 Gutters and Downspouts:- View of Galvanized Steel Perimeter Gutters & Downspout

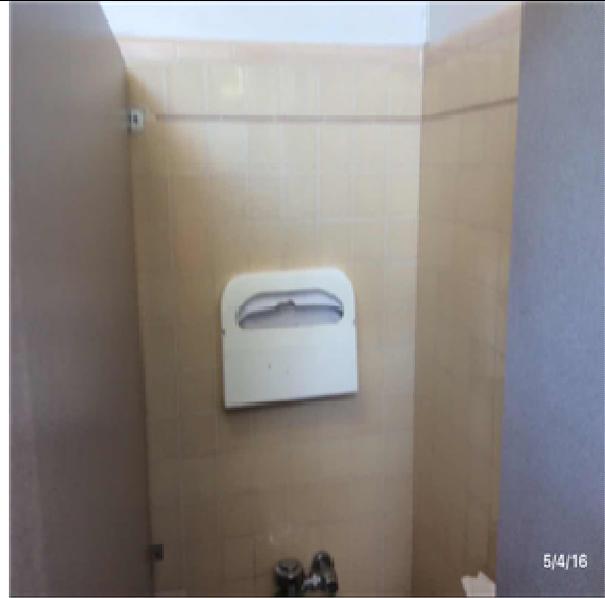
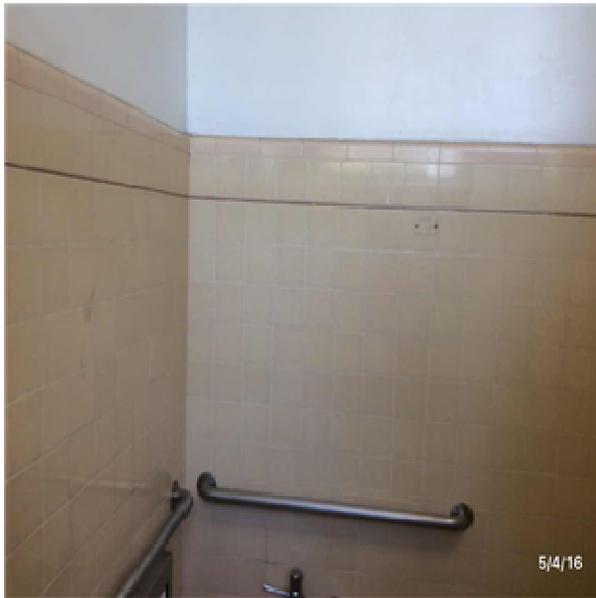
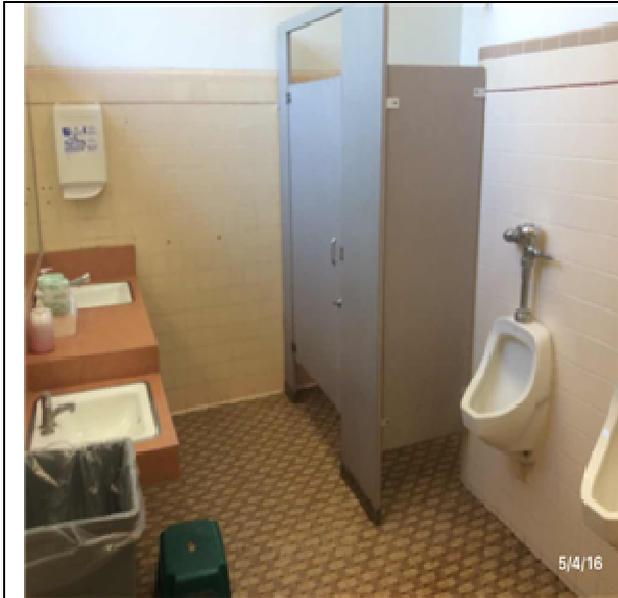
The interior wall finishes were observed to be in fair to poor condition. We anticipate the repainting of the interior surfaces early in the study period to maintain appearances. The ceramic tile at the restroom was in fair - poor condition given its age. The ceramic tile has an EUL of thirty years. We did not observe any broken or loose tiles or missing grout; therefore, we expect the ceramic tile to last beyond the study period. We are unaware of the age of the FRP panel, however, we did not observe any damage or discoloration, therefore we do not anticipate replacement in the study period.

C3012 Wall Finishes to Interior Walls:- View of Ceramic Wall Tiles

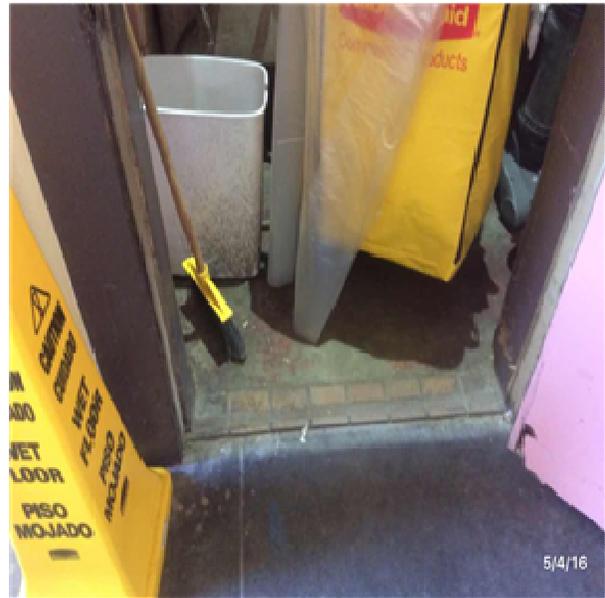
The floor finishes appeared in poor - fair condition throughout the building. We are unaware of the age of the epoxy floor covering at the janitor's room, however we assume it to be more than fifteen years of age, therefore based on the typical EUL of ten years for this type of covering and current observed condition, we anticipate replacement early in the study period. The ceramic tile at the restrooms was in fair - poor condition given its age. The ceramic tile has an EUL of thirty years. We did not observe any broken or loose tiles or missing grout; therefore, we expect the ceramic tile to last beyond the study period.

C3023 Hardeners and Sealers:- View of Epoxy Floor Coating

ID	Type	Recommendation	Priority	Year	Expenditures
135360	C3010	Replace Painted Finish - Standard	Priority 2	2016	\$2,646
135361	C3010	Replace Painted Finish - Standard	Priority 2	2024	\$2,646
135362	C3020	Replace Epoxy Floor Coating	Priority 2	2016	\$560
135363	C3030	Replace Acoustic Ceiling System - Standard	Priority 2	2018	\$2,346

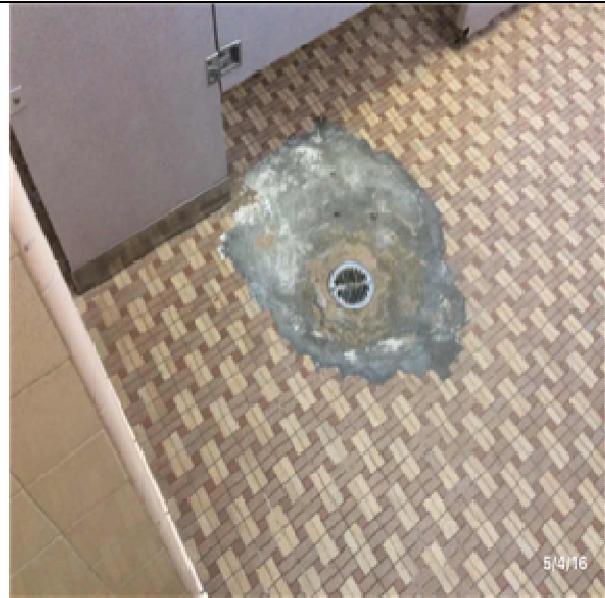
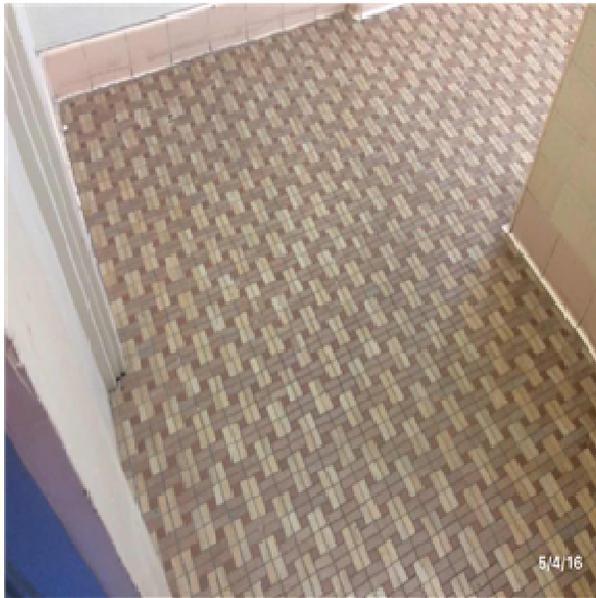
C3024 Flooring:- View of Ceramic Tile

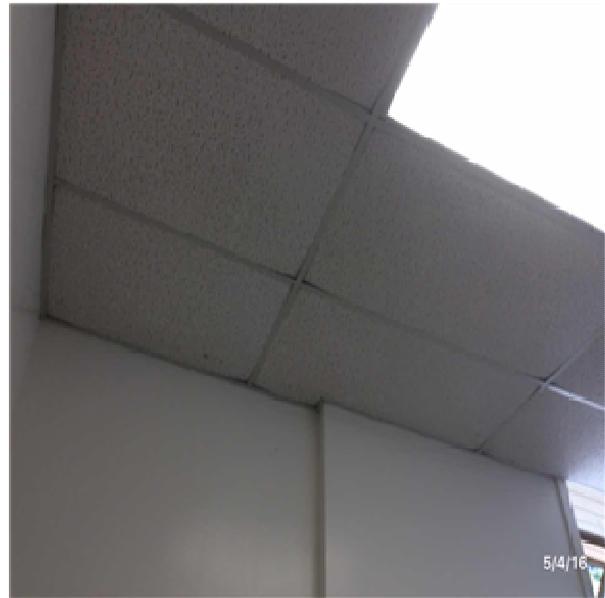
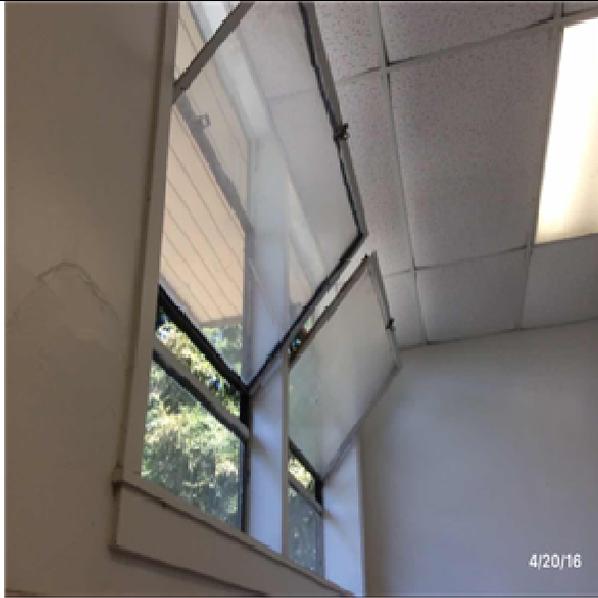
The acoustic tiles appeared in poor condition overall. We are unaware of the age; however we assume it to be more than fifteen years of age, therefore based on the typical EUL of twenty years for this type of ceiling and current observed condition, we anticipate replacement early in the study period.

C3032 Suspended Ceilings:- View of Acoustic Ceiling System - Standard

C3032 Suspended Ceilings:- View of Acoustic Ceiling System  
- Standard

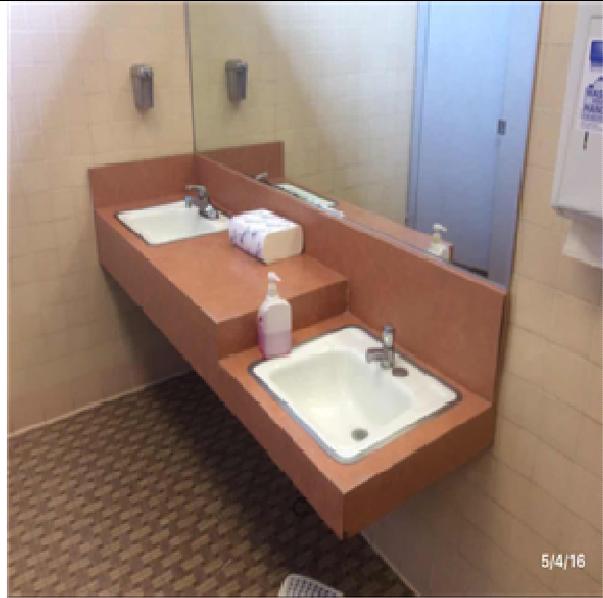
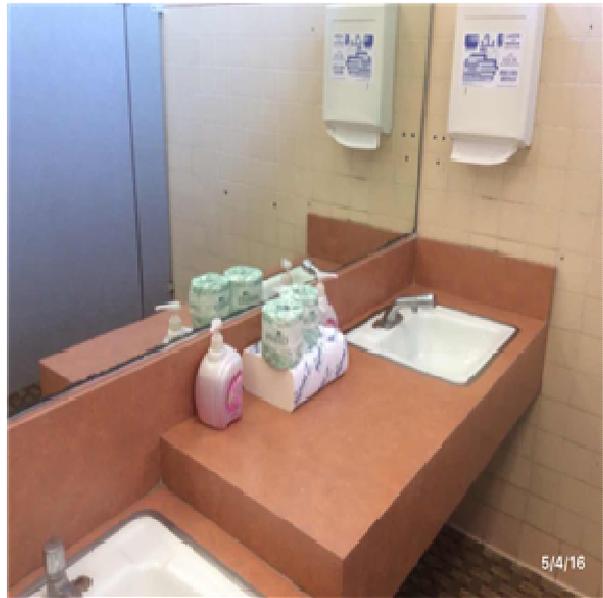
The lavatories were observed to be in poor condition. The lavatories drained properly and appeared to not have any cracks in the china; however, they are assumed to be original and based on their typical EUL of thirty-five years we recommend that they are considered for replacement during the study period. Maintenance personnel reported that the wall mounted closets are more prone to vandalism as the restrooms remain open to the public 24 hours.

D2013 Lavatories:- View of Vanity Top Lavatories

ID	Type	Recommendation	Priority	Year	Expenditures
135364	D2010	Replace D2010 Plumbing Fixtures	Priority 1	2020	\$6,776
135365	D2010	Replace Wall Mounted Water Closets	Priority 3	2020	\$11,200
135366	D2010	ADA Fixtures	Priority 1	2016	\$12,880
135367	D2010	Replace Service Sink Floor Mounted	Priority 2	2016	\$3,150
135368	D2010	Replace Vanity Top Lavatories	Priority 3	2020	\$5,250

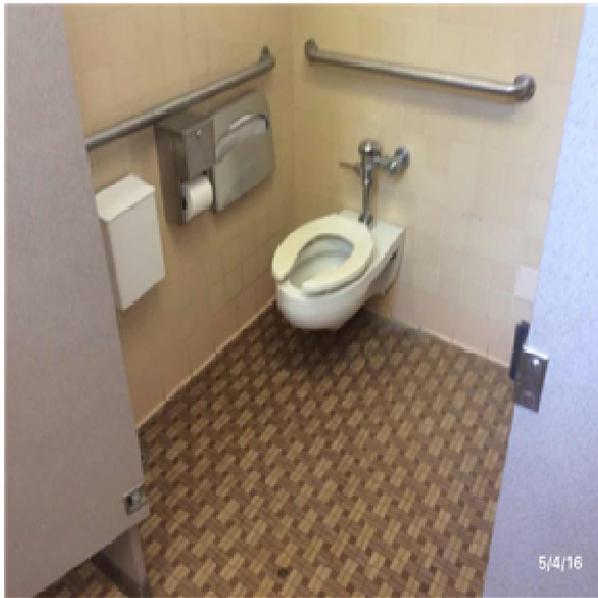
The water closets and urinals were observed to be in poor condition. Water closets such as this have an EUL of thirty-five years. We believe the water closets to be upgraded in 1985 therefore they are over thirty-five years old. We recommend a full replacement early in the study period. The flush valves may fail during the study period and therefore to maintain function they may need to be replaced. This work has not been included in this study as we anticipate it will be carried out on an as needed basis as part of routine maintenance.

D2011 Water Closets:- View of Wall Mounted Water Closets

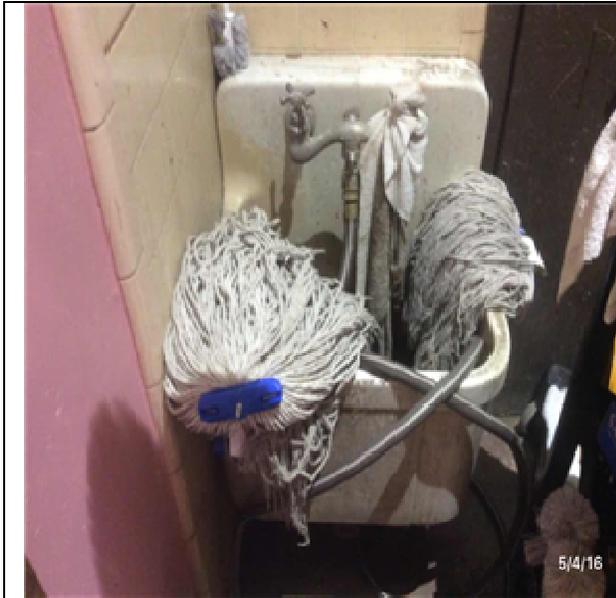
The sink was observed to be in poor condition. The sink drained properly and appeared to not have any cracks in the china; however, it is assumed to be original and based on their typical EUL of thirty-five years we recommend that they are considered for replacement during the study period.

D2014 Sinks:- View of Service Sink Floor Mounted

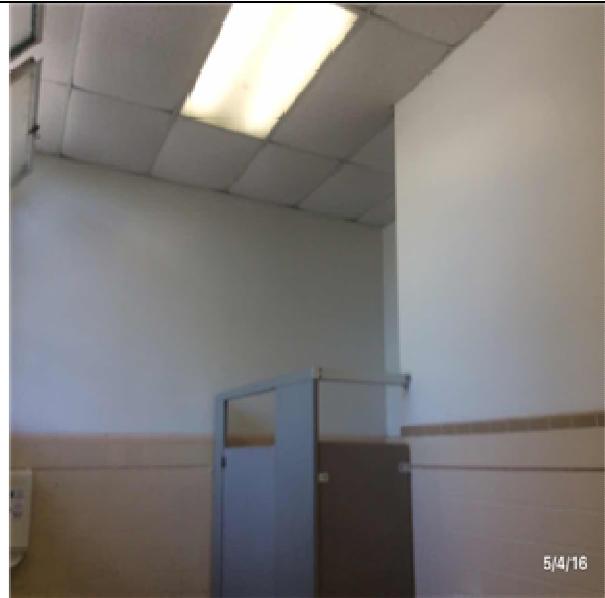
The interior lighting was observed to be in poor condition along with the suspended ceiling system itself. These recessed light fixtures typically have an EUL of 20 years; therefore based on observed condition they have been recommended for replacement early in the in the study period.

D5022 Lighting Equipment:- View of Interior Light Fixtures -  
Fluorescent

ID	Type	Recommendation	Priority	Year	Expenditures
135369	D5020	Replace Interior Light Fixtures - Fluorescent	Priority 2	2016	\$3,367
